# A-2 鋼連続箱桁橋の中間支点部の変形

Deformation of central support members of continuous steel box girder bridge

■ 位置 / 3号神戸線 神S-119~120 (芦屋市)

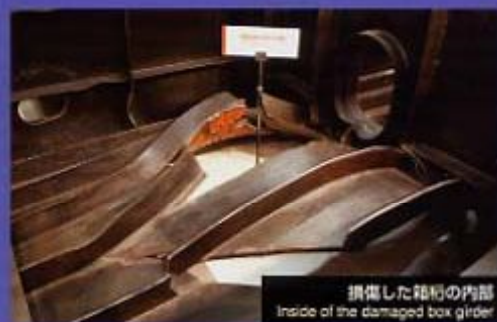
損傷した箱桁の内部  
Inside of the damaged box girder

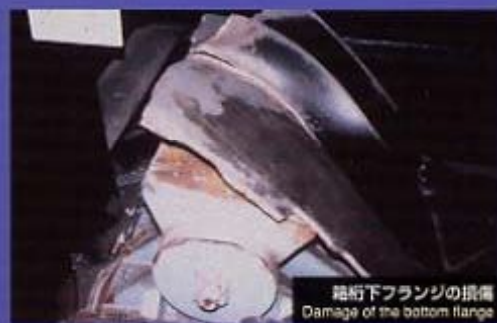
箱桁下フランジの損傷  
Damage of the bottom flange

■ 損傷内容 / ①神P-120橋脚上の固定支承(ピン支承)の上巻とピンが下巻からはずれた②水平方向の力により、上部工(箱桁)が、神戸側に約65cm、海側に約1m10cm移動した③破損したピン支承の下巻が、荷重を支えるための補強をしていない部分の箱桁下フランジを突き破った

■ Damage descriptions / ①Upper shoes and pins disengaged from the lower shoes in the fixed bearings (pin bearings) on the central pier (P-120). ②The box girders in the superstructure moved about 65 cm toward the east (Kobe side) and about 110 cm toward the south due to the horizontal force. ③The lower shoes of the damaged pin bearings broke through a bottom flange of the box girder where the load carrying reinforcement was not provided.

■ 復旧方法 / 桁下の交通規制条件を考え、損傷した部分を切り取り、新しい部材と取り替えた

■ Restoration / With traffic restrictions imposed on road below the bridge taken into account, the damaged members were cut out and removed, and subsequently new members were installed.
