# B-2 RC橋脚基部付近での曲げせん断破壊

Flexural shear failure around the base of reinforced concrete pier

■**位置**／3号神戸線 神P-36 (西宮市石在町)

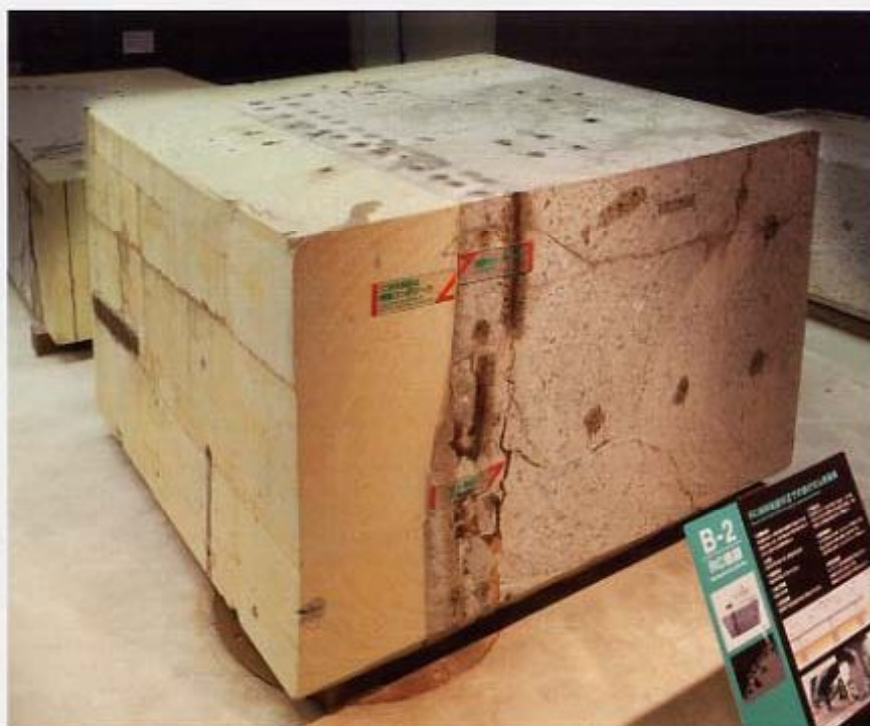
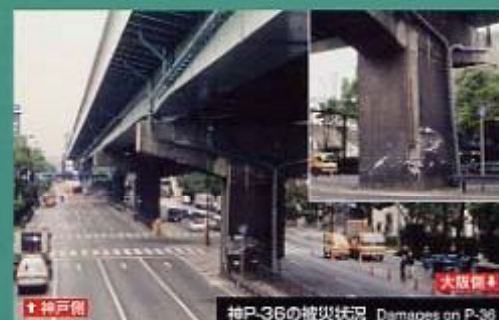
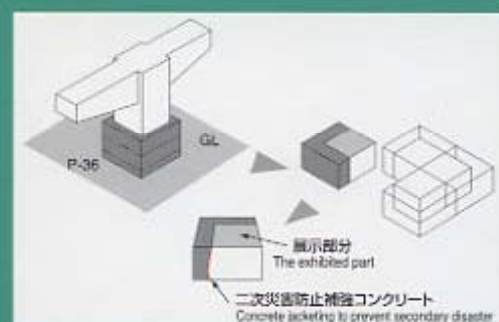
■**損傷内容**／柱基部付近に一部主鉄筋が座屈する曲げせん断損傷を受け、また、神戸側および梁の張り出しが大きい山側へ柱が残留傾斜した

■**Damage descriptions**／ Flexural shear failure was occurred at the column base with the buckling of longitudinal reinforcement, and resulted in a residual inclination toward the east (Kobe side) and also toward the north in which direction the beam had large overhang.

■**復旧方法**／柱基部において柱を切断・撤去し、その後、3.9m×3.9mの矩形RC柱を現場で構築し、工場で製作した鋼製梁を結合させ、再構築した

■**Restoration**／ The damaged column was cut at the base and removed, and subsequently a new reinforced concrete rectangular column (3.9 m × 3.9 m) was built on site. Finally a factory-fabricated steel beam was connected on it to complete the pier.
