# C-2 鋼製橋脚(円形)のわれ

Cracks in circular steel pier

■**位置**／3号神戸線 神P-609 (神戸市長田区)

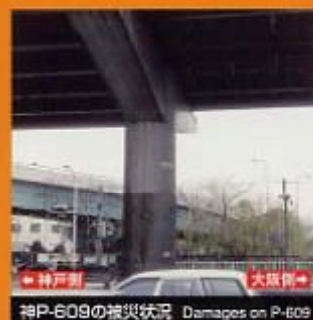
■**損傷内容**／外観上座層はほとんど認められなかったが、横補剛材間の溶接部全周にわれが発生していた

われが発生した部分(取り付けられている補強材は復旧までの二次災害を防止するためのもの)

■**Damage descriptions**／ Although almost no buckling was visible from the appearance, cracks were found in the welds between lateral diaphragms all around the pier.

■**Descriptions of the exhibits**／ Portion with cracks (The attached stiffeners were of temporary retrofit against secondary disasters until the complete restoration.)

■**復旧方法**／上部工を仮受けし、橋脚全体を基部から切断・撤去し、鋼製橋脚(直径2.0m、板厚40mm、材質SM570)で再構築した

■**Restoration**／ After underpinning the superstructure, the entire pier was cut at its base and removed out, and subsequently a new steel pier (diameter 2.0 m; thickness: 40 mm; material: SM570) was built.
