# B-1 RC橋脚基部付近での曲げせん断破壊

Flexural shear failure around the base of reinforced concrete pier

■ 位置 / 3号神戸線 神P-73 (西宮市川西町)

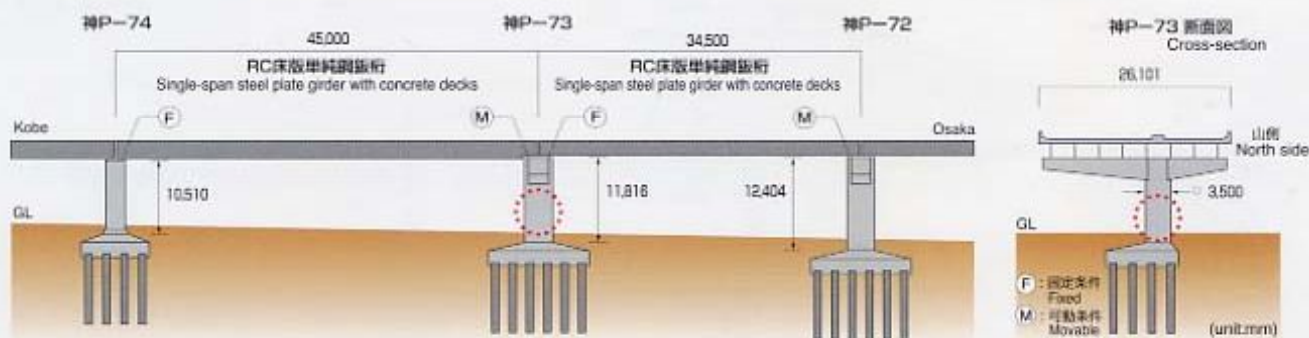
■ 展示物紹介 / 二次災害防止のため、コンクリートで巻き立て補強した部分を切断し、さらに分割したもの (橋脚の撤去は展示しているようなブロックで撤出した)

■ Descriptions of the exhibits / The damaged portion of the column around which had been temporarily jacketed with the concrete for secondary disaster prevention is exhibited. The column was divided into blocks to remove from the site, as shown here.
