# B-3 RC橋脚基部付近での曲げ破壊

Flexural failure around the base of reinforced concrete pier

■ **位置** / 3号神戸線 神P-236 (神戸市東灘区御影本町)

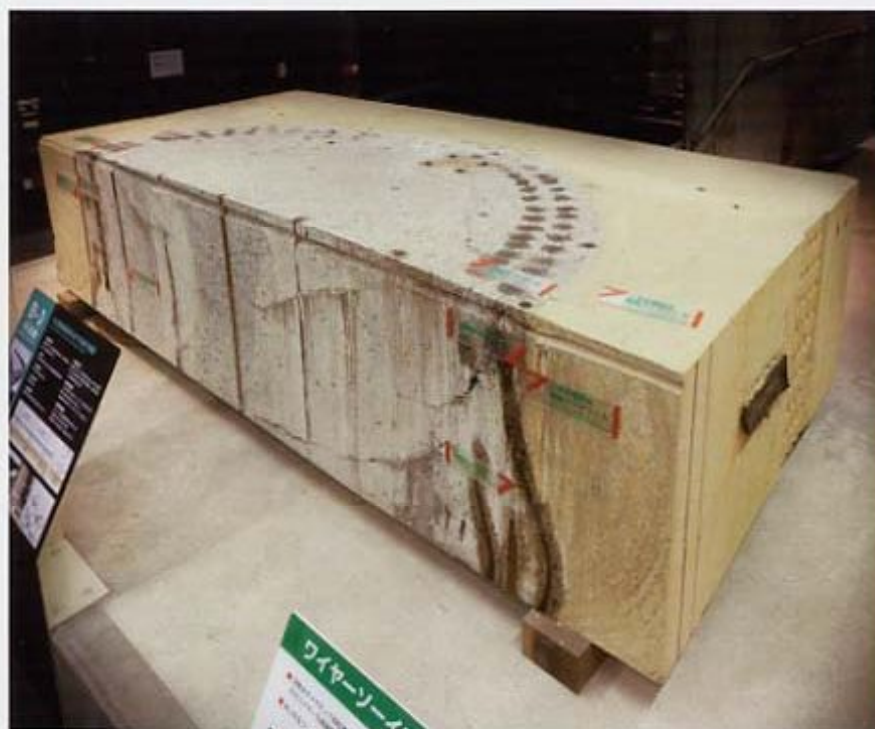
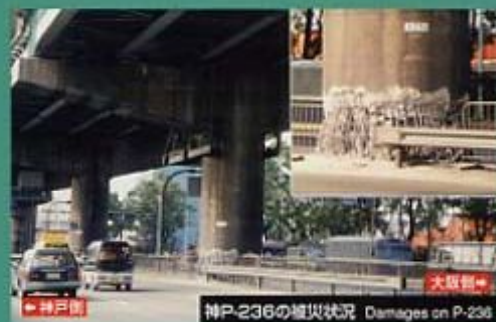
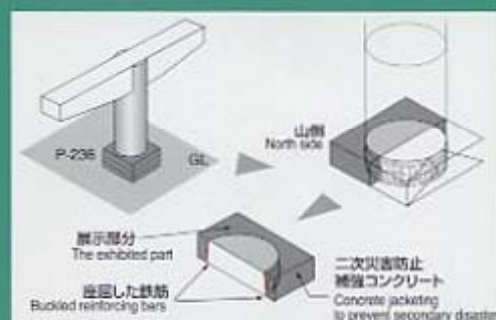
■ **損傷内容** / 柱基部付近で、主鉄筋が全周にわたって座屈する激しい曲げ損傷が生じた

■ **構造形式** / 円形RC単柱 直径3.0m

コンクリート設計基準強度 240kgf/cm<sup>2</sup>

主鉄筋 D32 (SD30) × 2段

帯鉄筋 D16 (SD30) × 300mmピッチ

■ **Damage descriptions** / Serious flexural failure was occurred at the column base with the buckling of longitudinal reinforcements.

■ **Structural configuration** / Reinforced concrete single cylindrical column with a diameter of 3.0 m

■ **復旧方法** / 柱基部において柱を切断・撤去し、その後、直径3.4mの円形RC柱を現場で構築し、工場で作成した鋼製梁を結合させた

■ **Restoration** / The damaged column was cut at the base and removed, and subsequently a new reinforced concrete cylindrical column (diameter: 3.4 m) was built on site. Finally a factory-fabricated steel beam was connected on it to complete the pier.
