B-6 RC橋脚基部付近での曲げせん断破壊

Flexural shear failure around the base of reinforced concrete pier

■ 位置 / 3号神戸線 神P-54 (西宮市莞茂町)

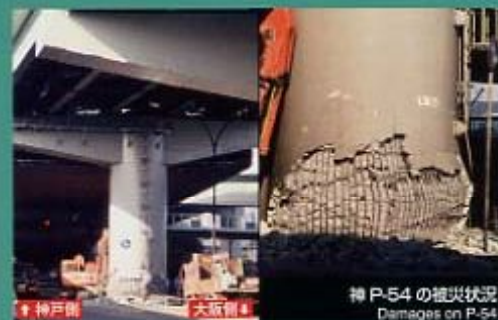
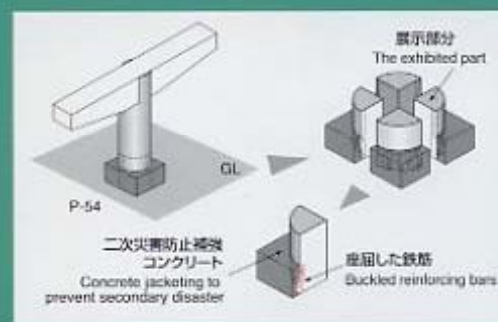
■ 損傷内容 / 柱基部付近において、主鉄筋が全周にわたって座屈し、帯鉄筋がばらける激しい曲げせん断損傷が生じた

■ 構造形式 / 円形RC単柱 直径3.5m

■ 竣工時期 / 昭和44年度

■ 適用基準 / 道路橋下部構造設計指針 (昭和41年) ほか

■ Damage descriptions / Severe flexural shear failure was occurred at the column base with the buckling of longitudinal reinforcement.

■ Structural configuration / Reinforced concrete single cylindrical column with a diameter of 3.5 m

■ Major standards applied / Design Guidelines for Highway Bridge Substructures (1966)

■ 復旧方法 / 柱基部において柱を切断・撤去し、その後、直径3.9mのRC柱 (円形) を現場で構築し、工場で作成した鋼製梁を結合させ、再構築した

■ Restoration / The damaged column was cut at the base and removed, and subsequently a new reinforced concrete cylindrical column (diameter: 3.9 m) was built on site. Finally a factory-fabricated steel beam was connected on it to complete the pier.
