# **C-3**

## 鋼製橋脚(円形)の局部座屈・われ

Local buckling and cracking in circular steel pier

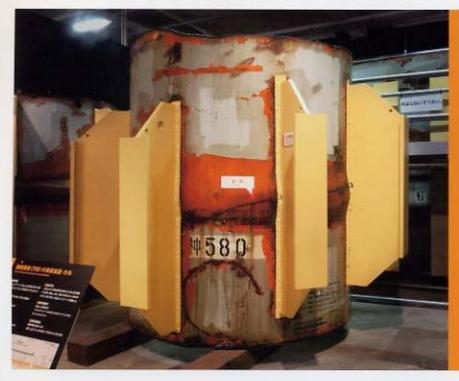
- ■損傷内容/中請めコンクリートと直上の機補剛材間に局部産屈が発生した。また、柱溶接部にわれが生じた
- ■位置/3号神戸線 神下P-580 (神戸市兵庫区)
- ■構造形式/円形鋼製橋脚 直径1.8m
- ■竣工時期/昭和42年度
- ■適用基準/銅道路橋設計示方書(昭和39年)ほか
- ■復旧方法/上部工および橋脚梁部を仮受けした後、柱を基部から切断・撤去し、新しい部材(板厚43mm、材質SM520C)と取り替え、中詰めコンクリートで補強した

撤去した損傷部分(取り付けられている補強材は復旧までの二次災害を防止するためのもの)

- Damage descriptions ✓ Local buckling occurred between the concrete filling portion and the lateral diaphragm just above it. Cracks occurred in the welds on the column.
- Location / P-580 of the Kobe Route #3 (Hyogo-ku, Kobe)
- Structural configuration / Steel cylindrical pier with a diameter of 1.8 m
- Completion 1967
- Major standards applied Design Specifications for Highway Steel Bridges (1964)
- Restoration / After underpinning the superstructure and pier beam members, the column was cut at its base and removed out, and subsequently a new member (thickness: 43 mm; material: SM520C) was installed and reinforced with the filling of concrete.
- Descriptions of the exhibits / Damaged and removed portion (The attached stiffeners were of temporary retrofit against secondary disasters until the complete restoration.)
