C-5

縦補剛材の座屈

Buckling of stiffeners in steel pier

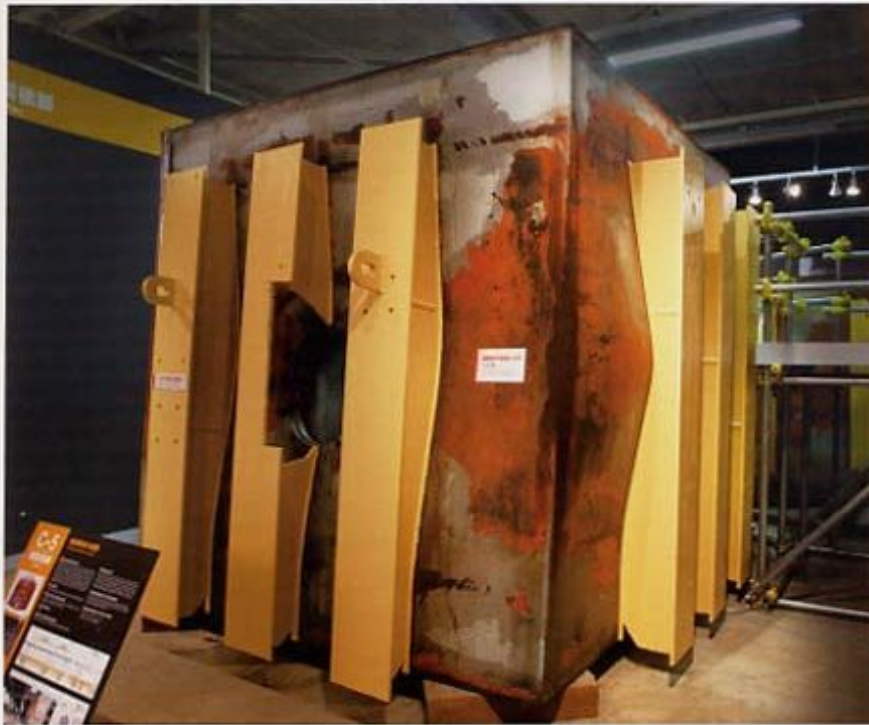
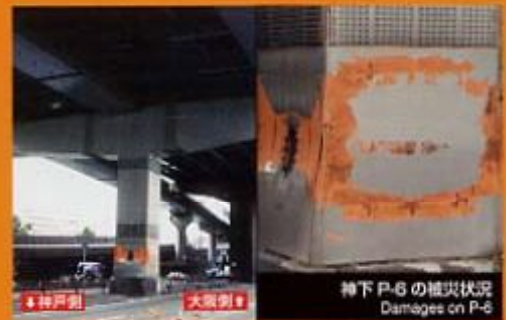
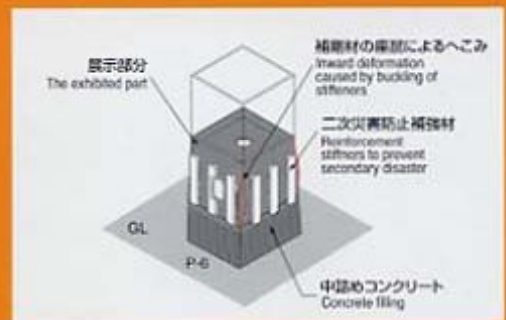
■ **損傷内容** / 大部分の上部工荷重を支える海側橋脚柱において、中詰めコンクリートと直上の横補剛材間に縦補剛材全体に座屈が生じた。海側山側2面がはらみ出し、大阪側神戸側2面がへこんだ状態になった。大阪側に設置したマンホールが弱点になったと考えられる。

■ **Damage descriptions** / Buckling of the entire stiffeners occurred between the filling concrete portion and the lateral diaphragm just above it in the column of the south pier which was carrying most loads of the superstructure. The column deformed outward in the north and south faces and inward in both the east (Kobe side) and west (Osaka side) faces. A manhole provided in the Osaka side was considered to have served as a weakness in this incident.

■ **復旧方法** / 上部工・橋脚梁部を仮受けした後、柱の最下段のブロック切断・撤去し、新しい部材(板厚40mm、材質SM520C)と取り替えた。また、橋脚内部の中詰めコンクリートの設置範囲を梁部下まで高くした。

■ **Restoration** / After underpinning the superstructure and pier beam members, the damaged column was cut at its bottom block and removed out, and subsequently a new member (thickness: 40 mm; material: SM520C) was installed. The level of the concrete filling the pier was raised to the bottom of the beam.

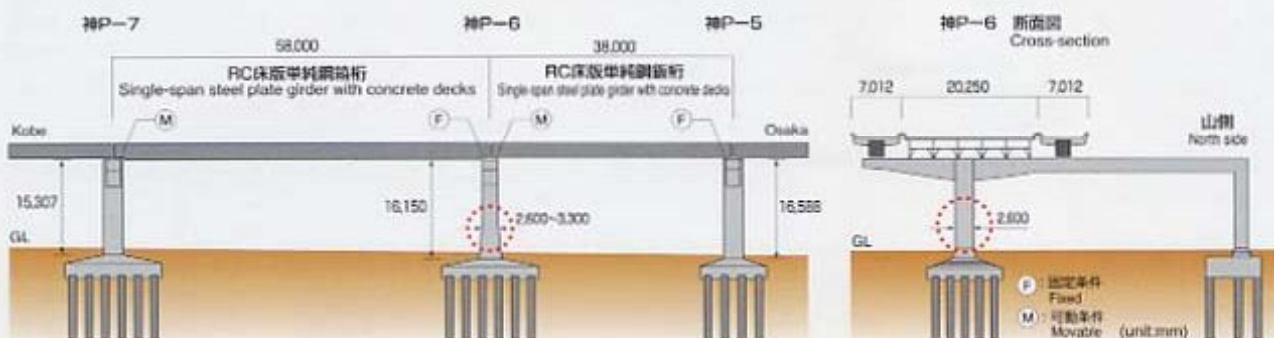
■ **展示物紹介** / 撤去した損傷部分(取り付けられている補強材は復旧までの二次災害を防止するためのもの)

■ **Descriptions of the exhibits** / Damaged and removed portion (The attached stiffeners were of temporary retrofit against secondary disasters until the complete restoration.)
