# B-3 RC橋脚基部付近での曲げ破壊

Flexural failure around the base of reinforced concrete pier

■ **位置** / 3号神戸線 神P-236 (神戸市東灘区御影本町)

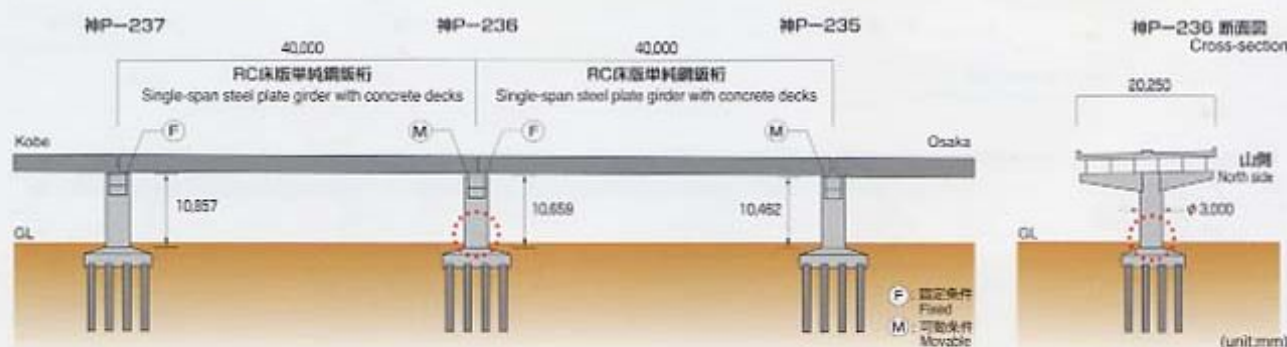
■ **損傷内容** / 柱基部付近で、主鉄筋が全周にわたって座屈する激しい曲げ損傷が生じた

■ **展示物紹介** / 二次災害防止のため、コンクリートで巻き立て補強した部分を2分割したものの一つ (橋脚の撤去は展示しているようなブロックで撤出した)

■ **Damage descriptions** / Serious flexural failure was occurred at the column base with the buckling of longitudinal reinforcements.

■ **Descriptions of the exhibits** / The damaged portion of the column around which had been temporarily jacketed with the concrete for secondary disaster prevention is exhibited. The column was divided into two blocks to remove from the site, as shown here.

■ **復旧方法** / 柱基部において柱を切断・撤去し、その後、直径3.4mの円形RC柱を現場で構築し、工場で作成した鋼製梁を結合させた

■ **Restoration** / The damaged column was cut at the base and removed, and subsequently a new reinforced concrete cylindrical column (diameter: 3.4 m) was built on site. Finally a factory-fabricated steel beam was connected on it to complete the pier.
