B-6 RC橋脚基部付近での曲げせん断破壊

Flexural shear failure around the base of reinforced concrete pier

■ 位置 / 3号神戸線 神P-54 (西宮市莞茂町)

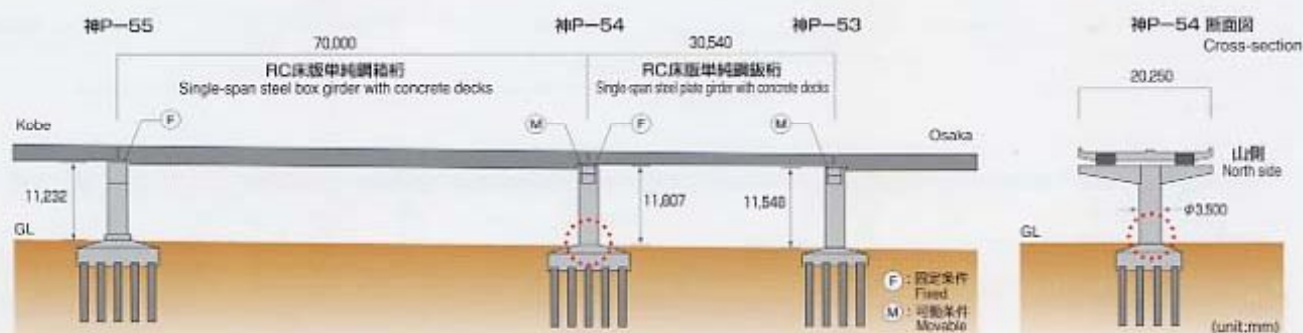
■ 損傷内容 / 柱基部付近において、主鉄筋が全周にわたって座屈し、帯鉄筋がばらける激しい曲げせん断損傷が生じた

■ Damage descriptions / Severe flexural shear failure was occurred at the column base with the buckling of longitudinal reinforcement.

■ 復旧方法 / 柱基部において柱を切断・撤去し、その後、直径3.9mのRC柱 (円形) を現場で構築し、工場で作成した鋼製梁を結合させ、再構築した

■ Restoration / The damaged column was cut at the base and removed, and subsequently a new reinforced concrete cylindrical column (diameter: 3.9 m) was built on site. Finally a factory-fabricated steel beam was connected on it to complete the pier.
